WA-II-485 Frame House

Maryland Historical Trust State Historic Sites Inventory Form

Survey No. WA-II-485

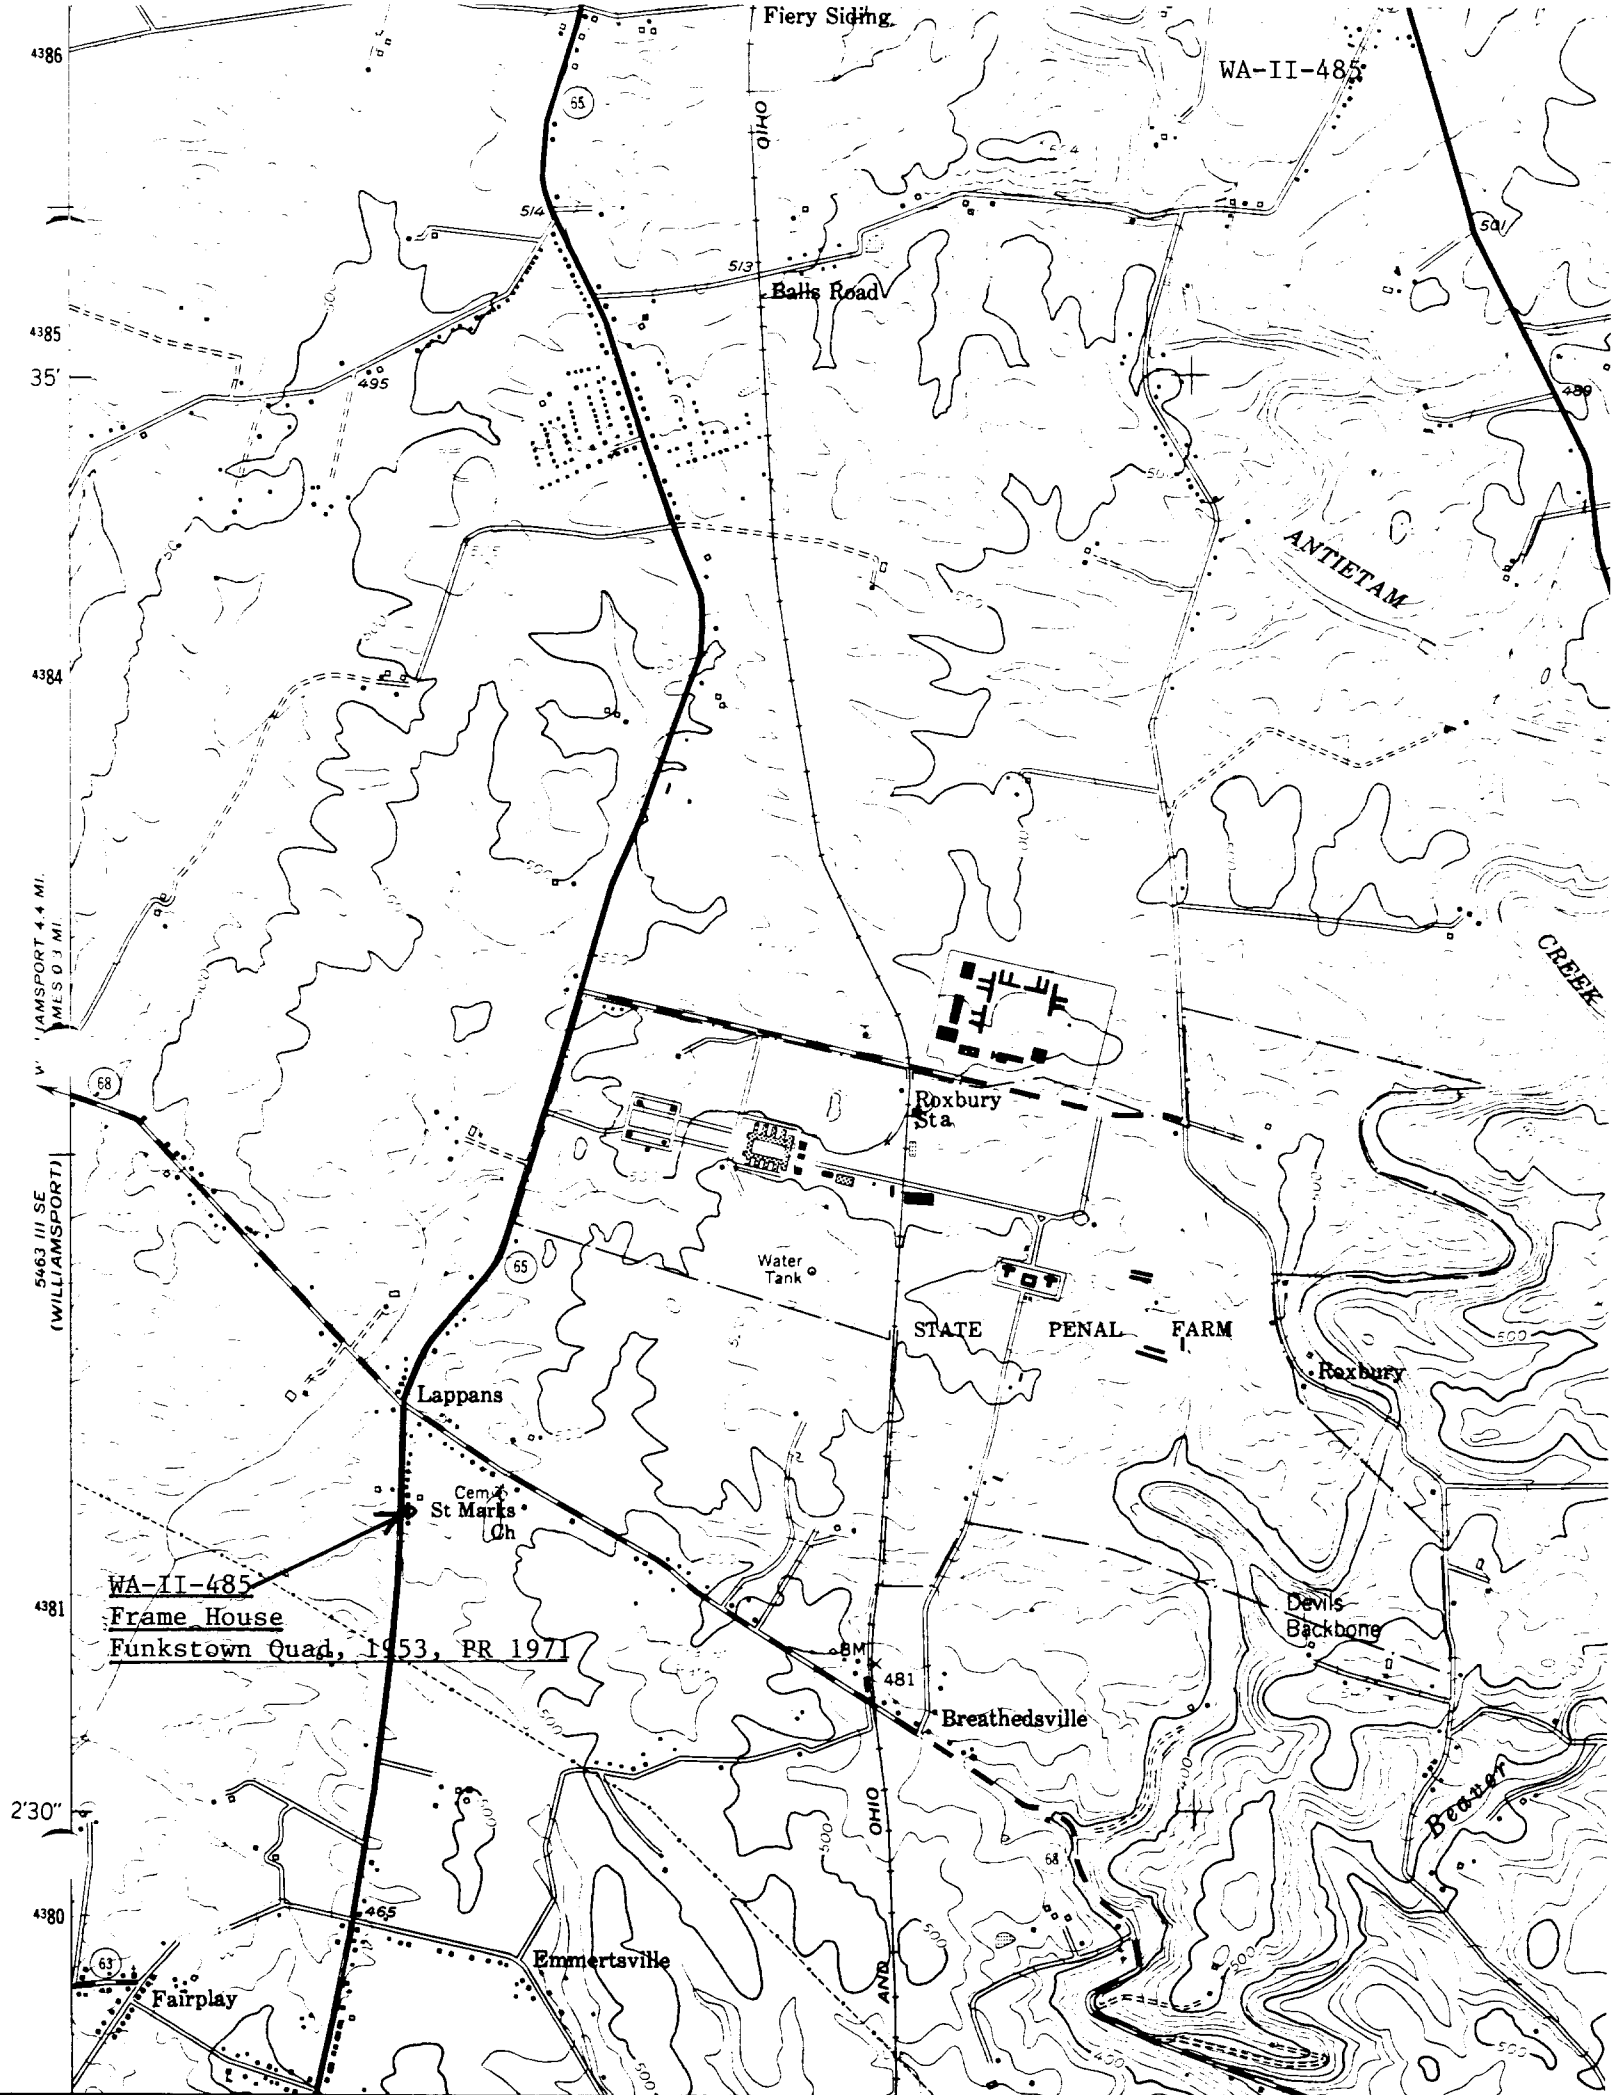
1. Frame House WA-II-485
2. Washington County, Maryland
3. Joe Getty
4. May 1983
5. Maryland Hist. Trust, Annapolis, Md.
6. West & north facades; camera facing
southeast
7. 1/1
